LITANI RIVER BASIN MANAGEMENT SUPPORT (LRBMS) DAM INSTRUMENTATION EVALUATION AND RECOMMENDATIONS

April 2010

This report was made possible by the United States Agency for International Development (USAID). It was prepared by International Resources Group (IRG).

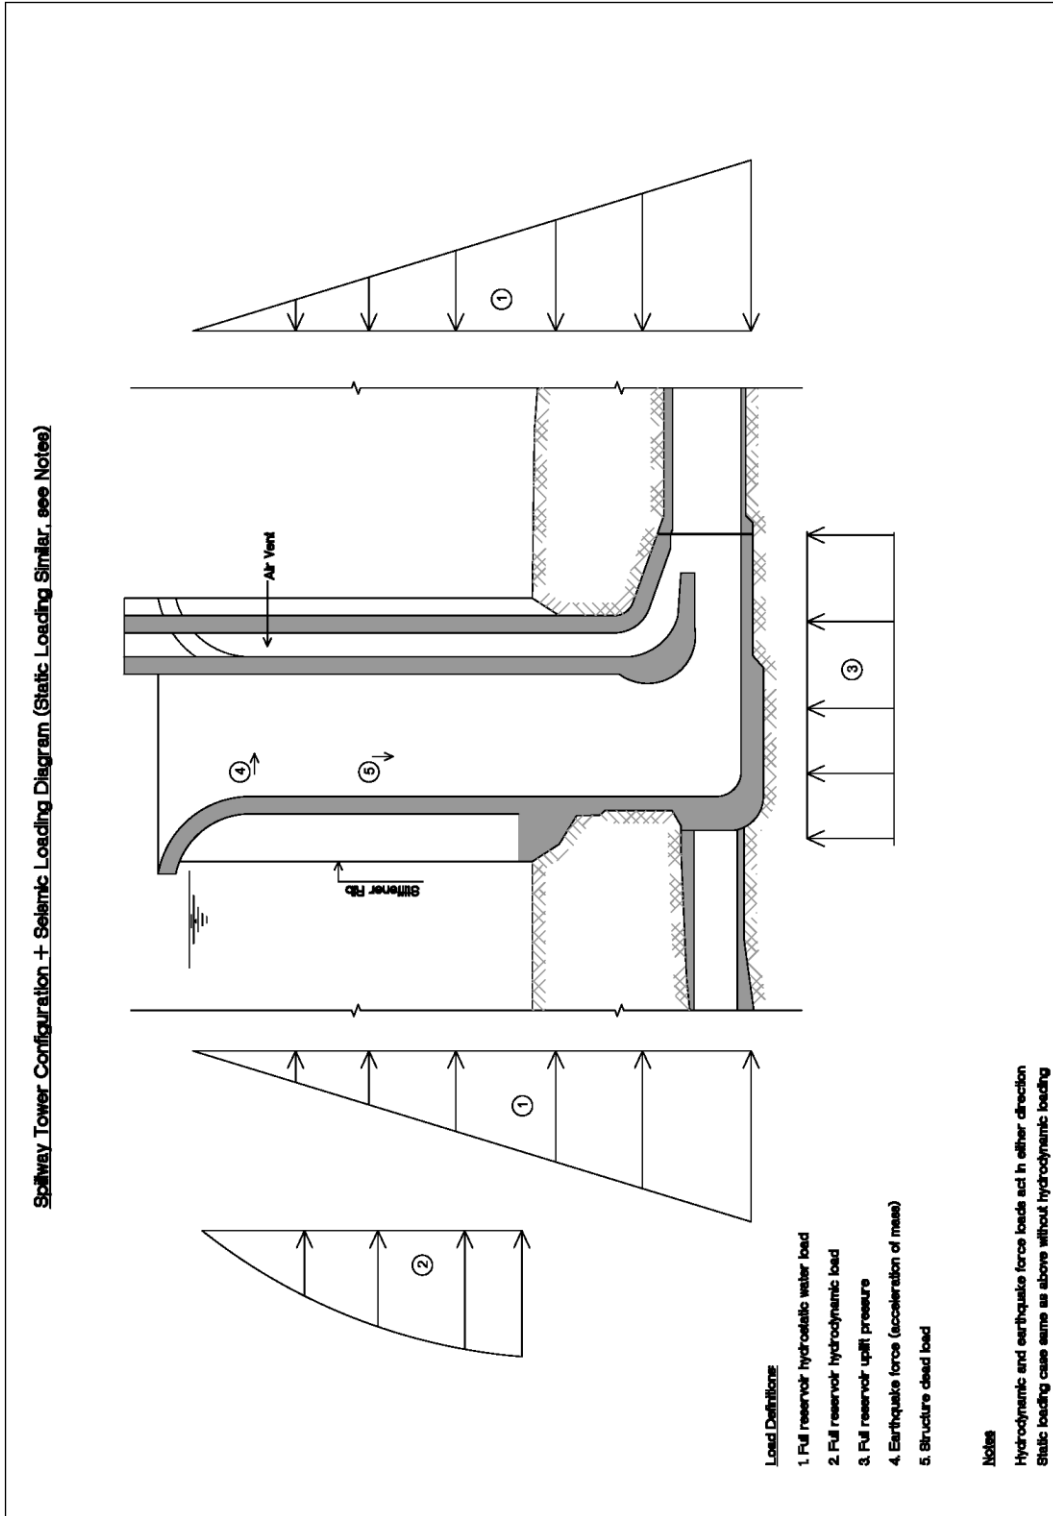
Figure 3 – Qaraoun Spillway Configuration and Seismic Load Diagram

6) PFM: Spillway Tower Failure Due to Cavitation

FERC Category: IV, This potential failure mode was ruled

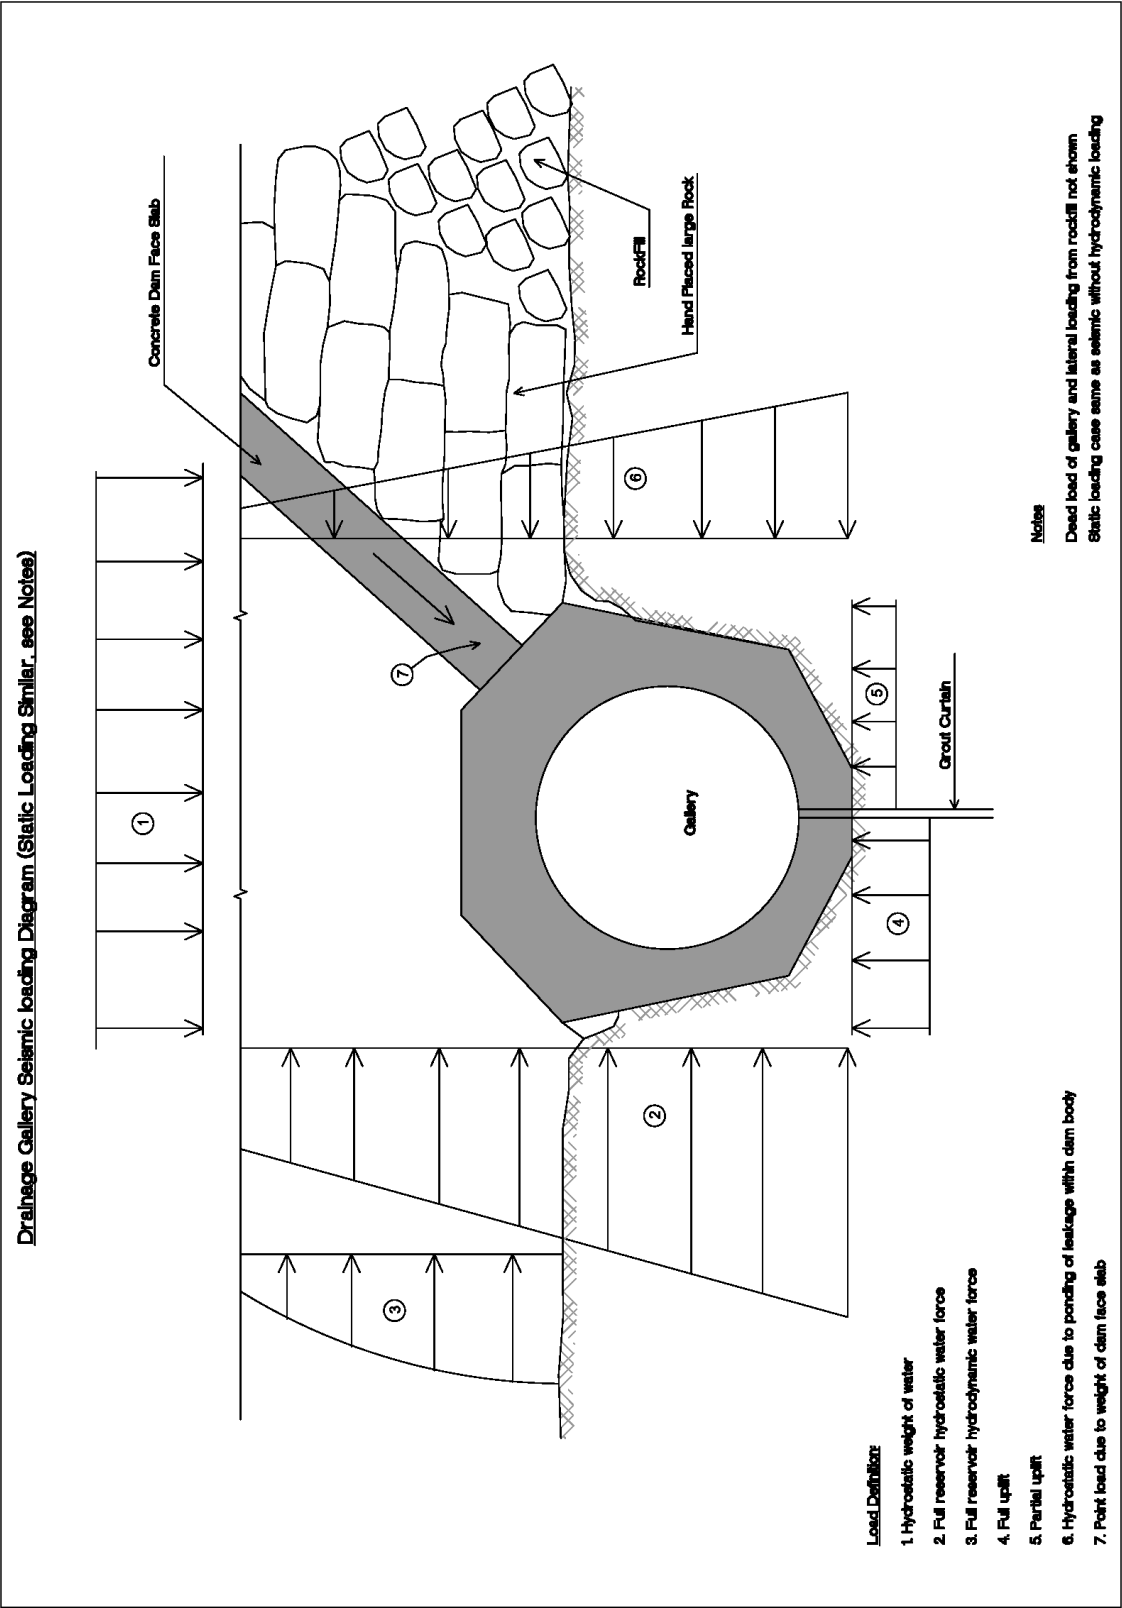
Figure 4 – Qaraoun Dam Drainage Gallery and Seismic Loading Diagram

7) PFM: Dam failure from collapse of drainage gallery at upstream (U/S) toe of dam due to flood loading

Loading: Hydrostatic reservoir loading under flood conditions coupled with face slab dead load reservoir sediment loading and saturated rock load

FERC Category: IV, Potential failure mode ruled out for dam breach and category II for failure of the gallery
